Manhole Inspection Summary

Manhole # S29MM1075MH

Record Plat: **29MM1** Node: **075** Status: **New Manhole (Not in GIS)** Insp Date: **3/19/07 12:00 AM**

Location Address: **4437 WICKFORD RD** Cross Street: **COLD SPRING LN**

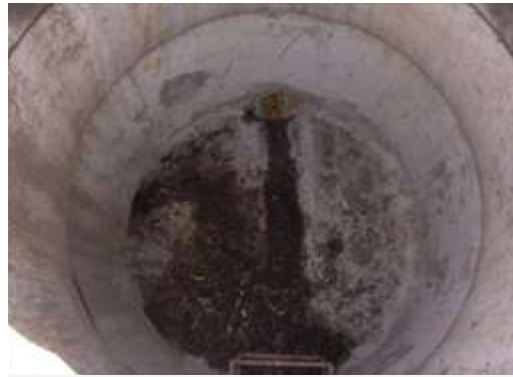
Top View

Corroded steps. Channel debris.

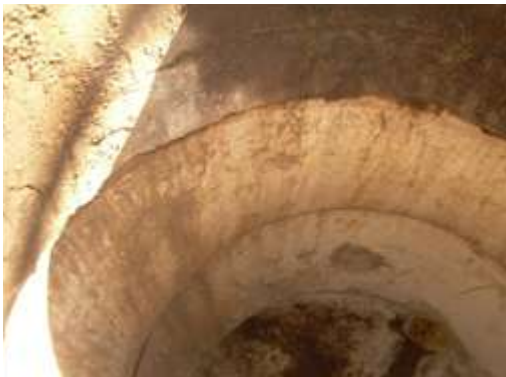
Defect

Frame leaks. Corbel and Barrel infiltration.

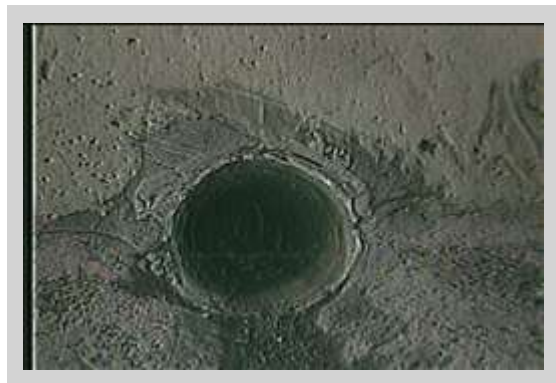
Pipe Out @ 12 O'Clock

Pipe Seal Cond: **Cracked**
